Sounding the Depths

Mapping the Wreckage of TWA Flight 800

**CDR Nicholas E. Perugini
LTJG Shepard M. Smith**

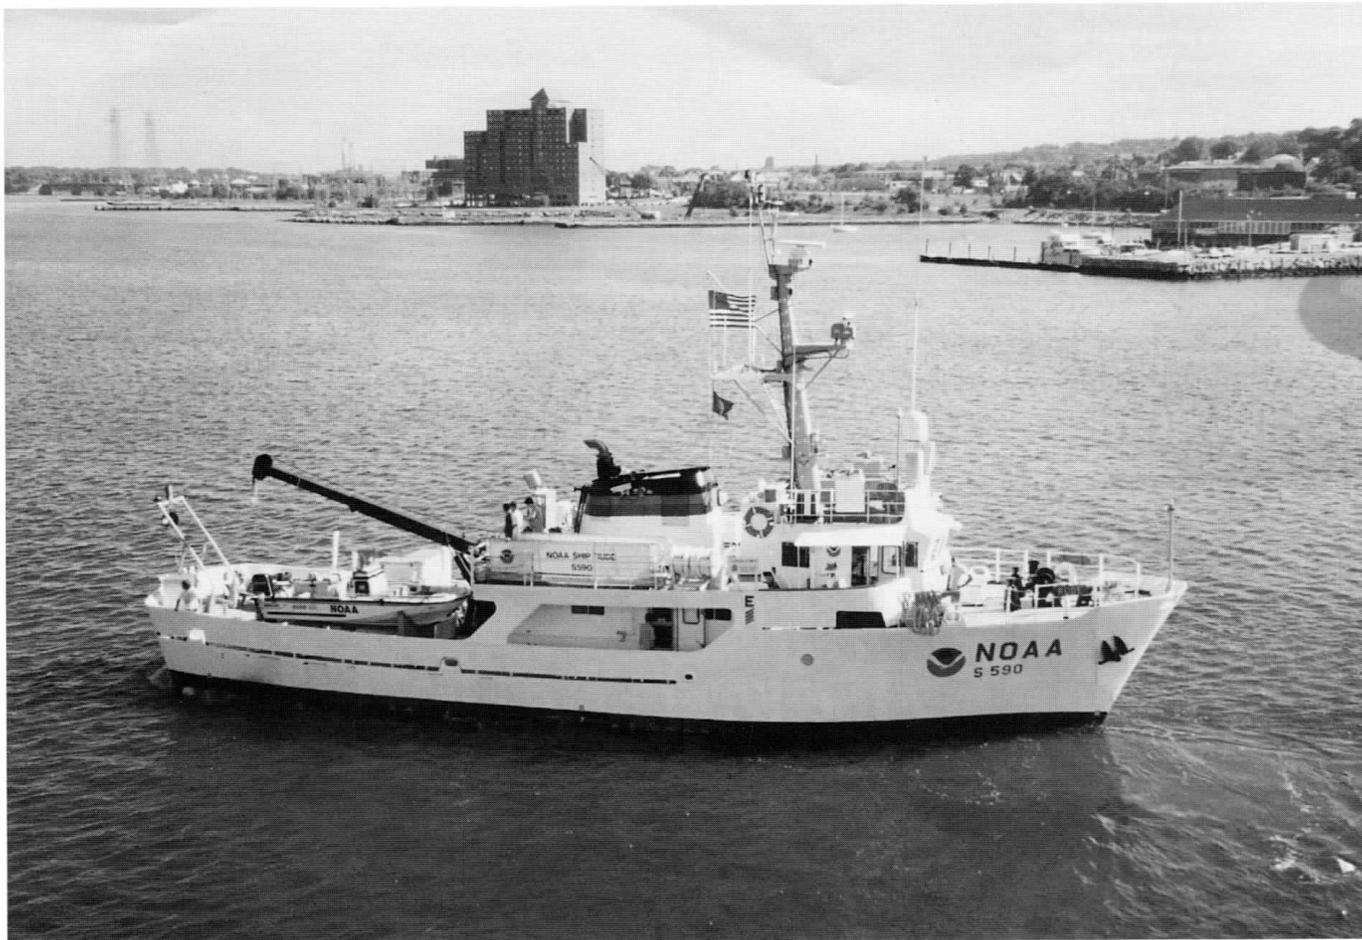
The National Oceanic and Atmospheric Administration ship *Rude* was one of many vessels that helped map the wreckage site and recover valuable debris .

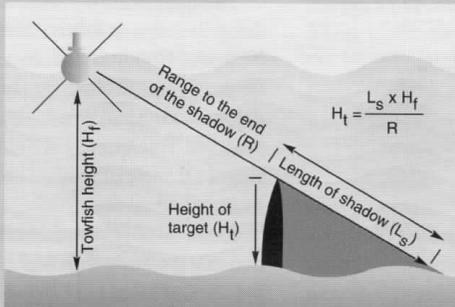
The side scan sonar is composed of two major components. The vessel pulls a torpedo-shaped towfish, connected by a cable, underwater at a fixed distance above the bottom.

The towfish has two transducers, one on the port and one on the starboard. Each transducer emits sound waves at regular intervals. As the acoustic energy from an individual pulse strikes the bottom, or a feature above the bottom, a 12-inch paper recorder notes the necessary data in real time. Stronger echoes appear darker, weaker echoes appear lighter. The

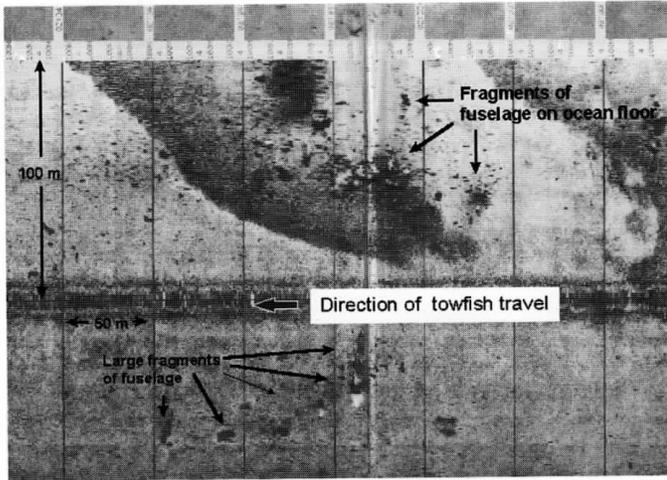
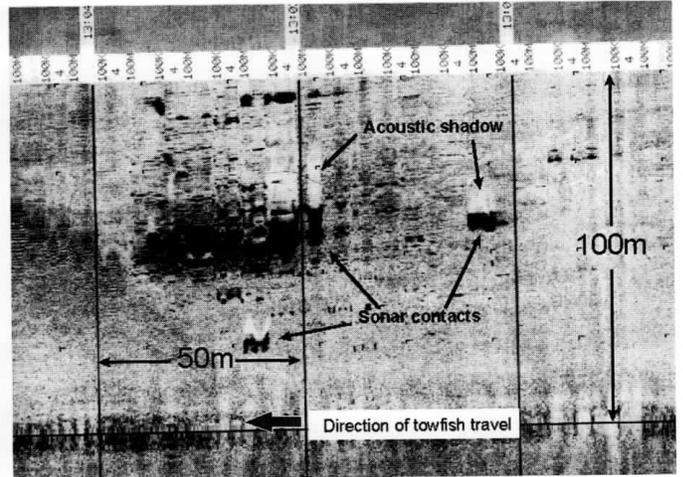
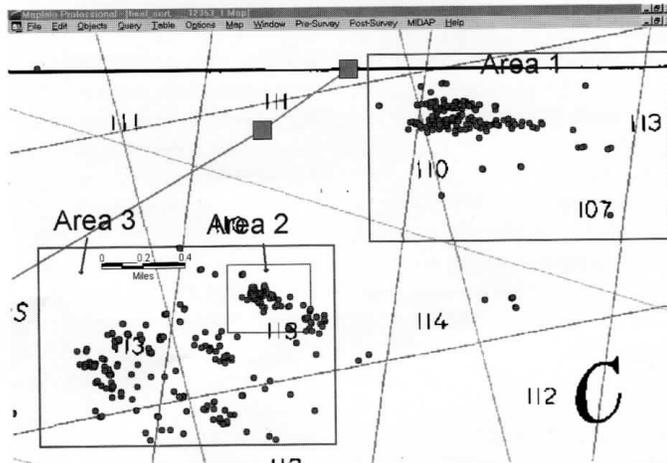
The *Rude* discovered two major areas of wreckage. Top left is a side scan sonar image of the first area; sand waves can be seen on the ocean floor in the upper-left part of this figure. To the right is a side scan image of the second area. Middle left is a GIS display of the flight line and side scan sonar contacts

over the nautical chart. To the right is a head-on view of the towfish. The "valleys" and "peaks" on the ocean floor obscure the reflection of the sound pulses, causing acoustic shadows to appear on the sonar record. Bottom image shows the sonar contact names for use by the diving teams.

Each day, the *Rude*'s Boston Whaler, along with Coast Guard vessels, traveled from the search area to the Coast Guard base, shuttling data to the shore team. The first sonar images the *Rude* sent ashore on Monday were stunning, showing two major concentrations of wreckage. A third area, approximately 2 miles up-track (west) of the two concentrated areas, showed a more scattered debris field.

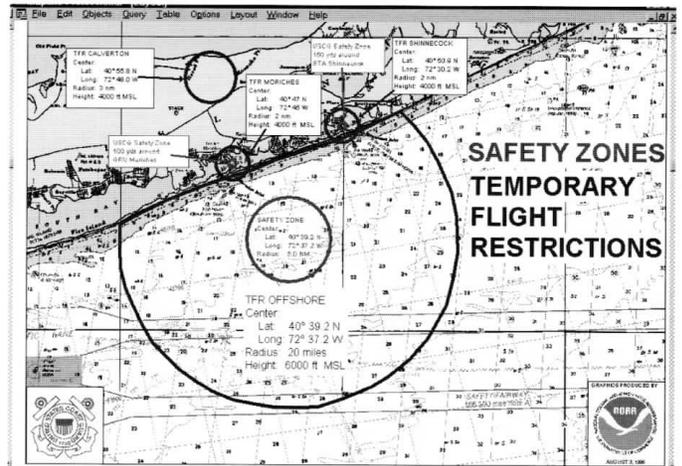
NOAA's GIS proved valuable, enabling the agency to produce surface and flight restriction plots, such as the one above, for other recovery teams.

In addition, NOAA coordinated with the Coast Guard to define and create maps of the no-fly and surface restriction zones around the crash site. The NOAA team produced both page-size and full-size mylar and paper plots for enforcement personnel and for use at the Coast Guard command center.
